Thermografieforum Eugendorf vom 26.-27.09.2014.

# THERMOGRAPHIC ACTIVITIES IN THERMOLAB

Faculty of Mechanical Engineering and Naval Architecture  
University of Zagreb

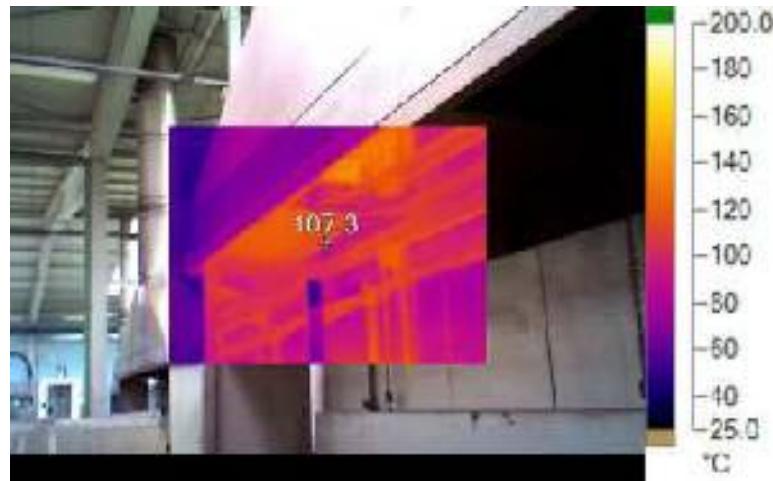
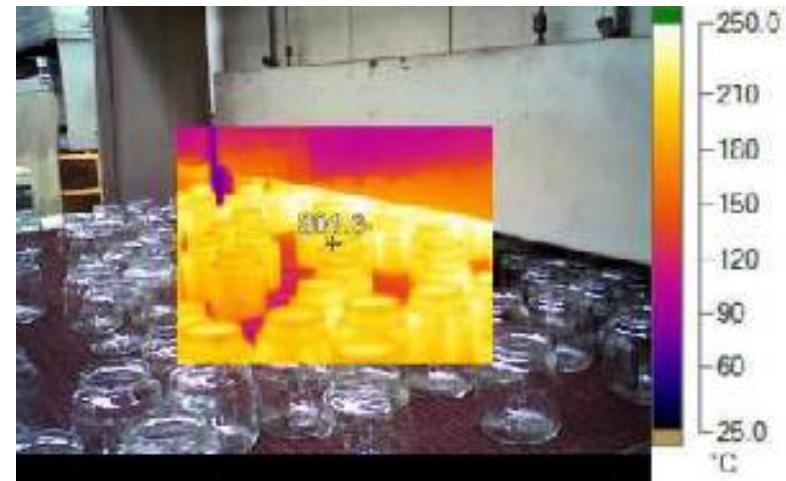
Thermograms obtained on the production line surfaces

This thermograms will be compared with those which will be taken after reconstruction.

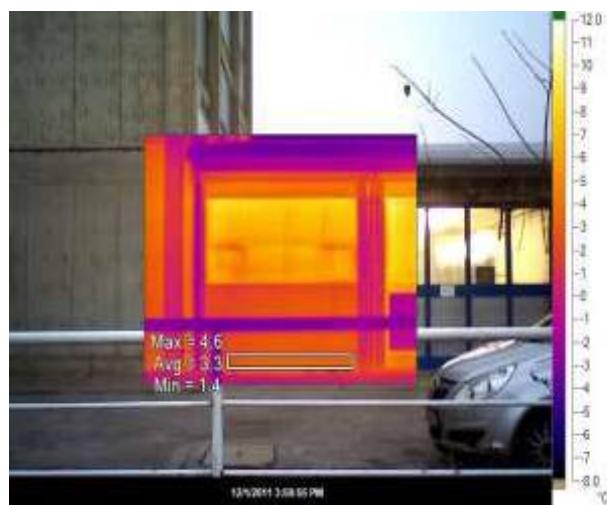
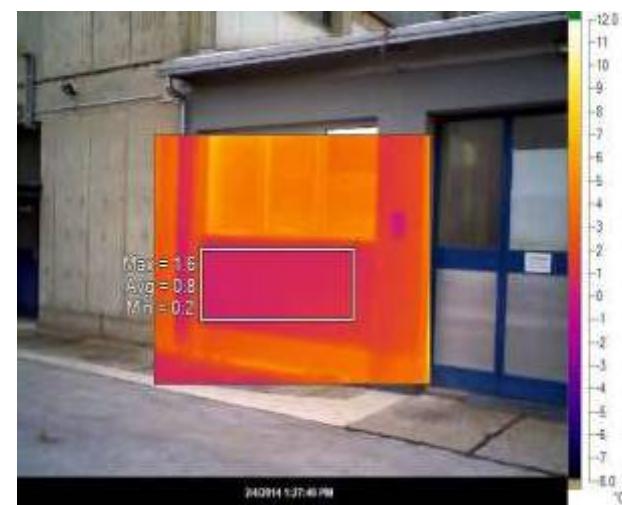
South facade

It can bee seen from the thermograms the quality of works and advantages of insulation which ensure the better energy efficiency of building.

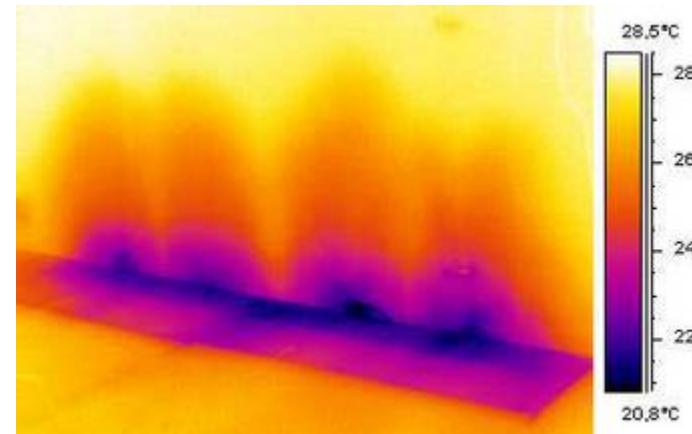
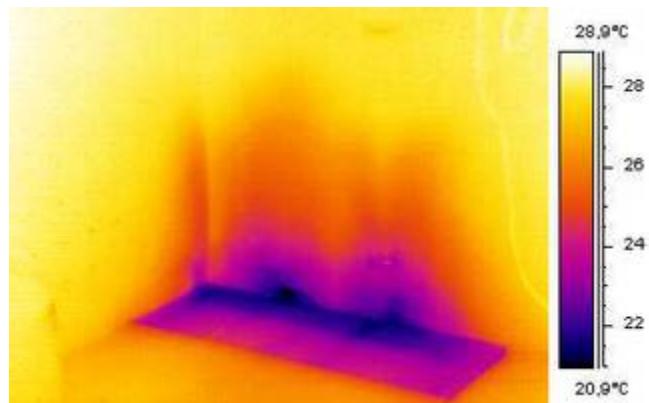
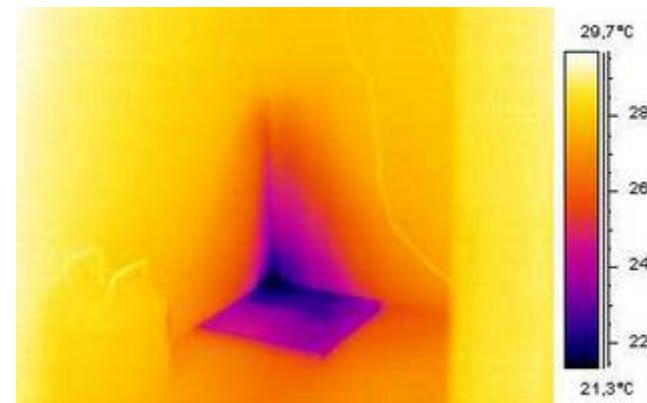
Average air temperature 27,6 °C

Water temperatures 16/18 °C

Water flow 99,6 kg/h

Fan velocity number 1

Cooling capacity 228 W

- unequal flow through convector
- unsatisfactory air profile in heating mode
- unsatisfactory air profile in cooling mode (acceptable at fan velocity number 3)

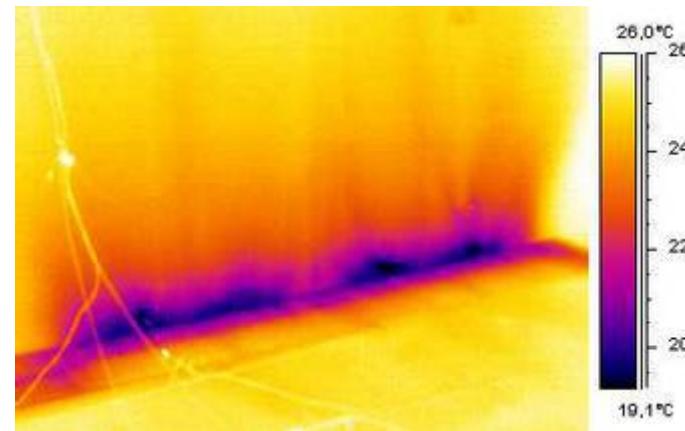
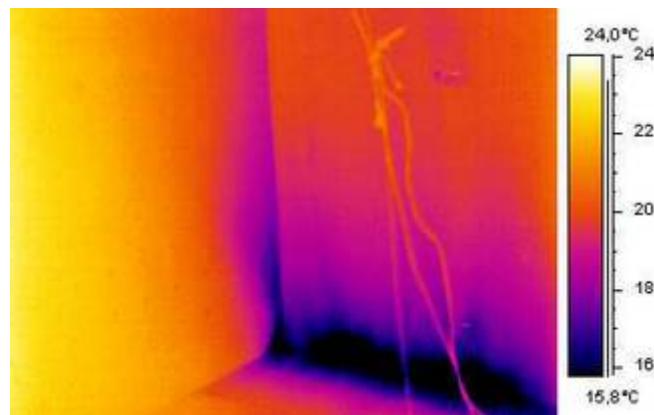
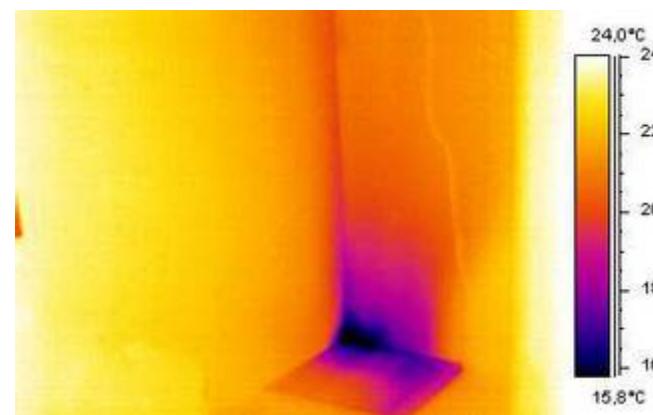
Average chamber air temperature 26,5 °C

Water temperatures 15,6/17,75 °C

Water flow 395,7 kg/h

Fan velocity number 3

Cooling capacity 990 W

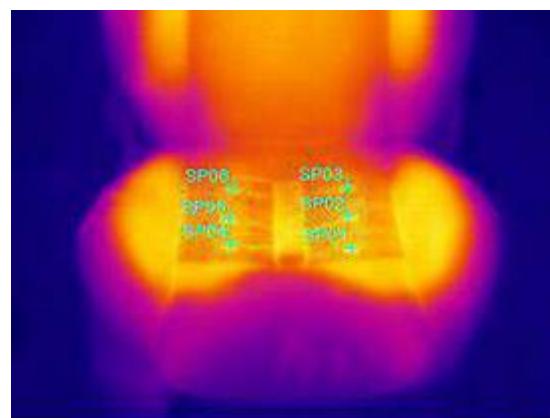
Temperature distribution on  
driver seat with insert set in

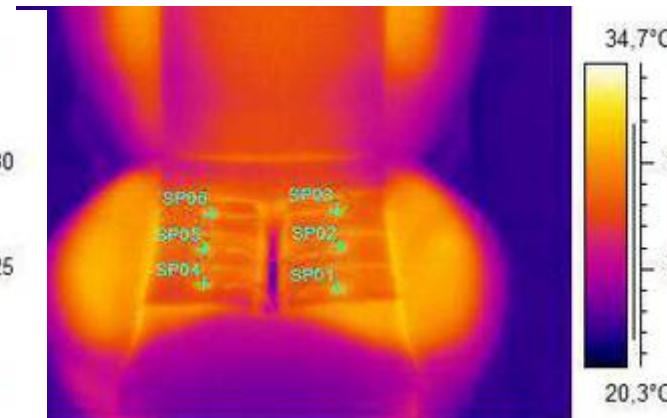
Temperature distribution on  
driver seat without insert

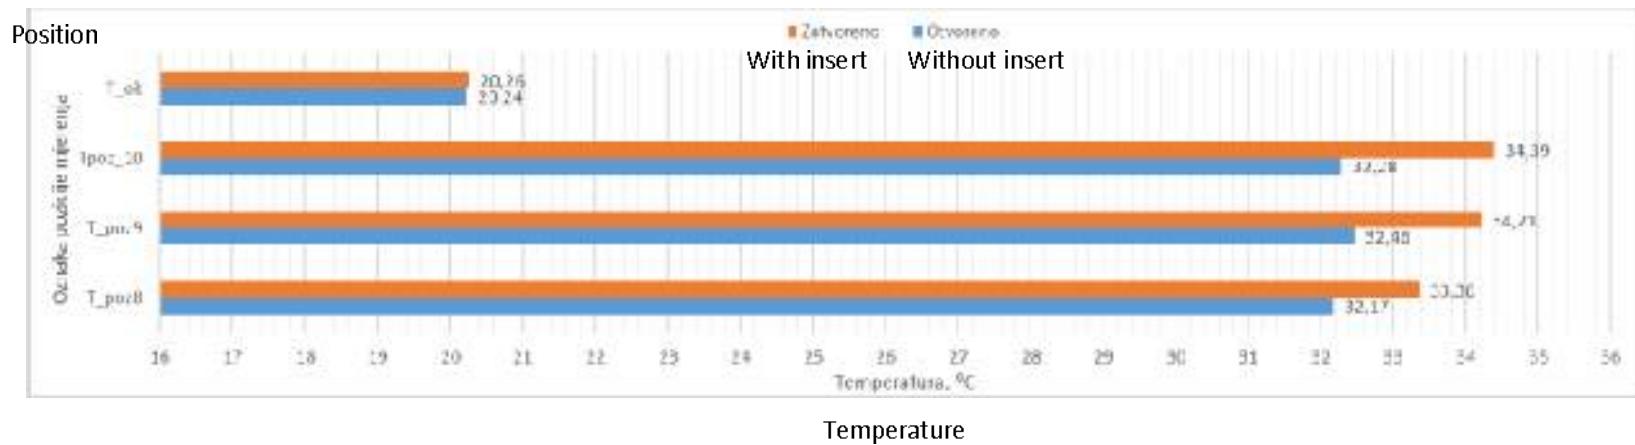
The temperatures on the seat remains more or less the same, with and without the insert, after seating duration of one hour. Such result was expected in the temperature domaine. The temperatures were recorded by thermographic camera FLIR 2000 SC and thermocouples.

Temperatures on the insert versus temperatures in the hole
