Thermografieforum Eugendorf vom 26.-27.09.2014.

# THERMOGRAPHIC ACTIVITIES IN THERMOLAB

Faculty of Mechanical Engineering and Naval Architecture  
University of Zagreb

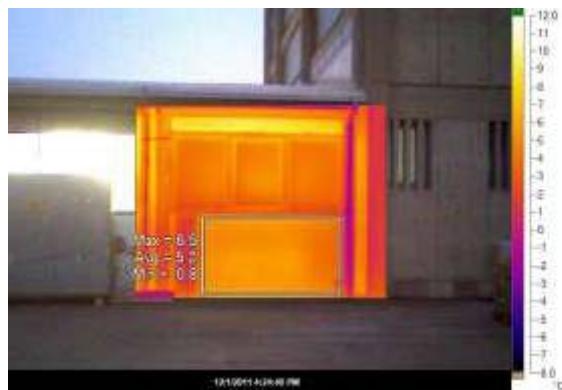
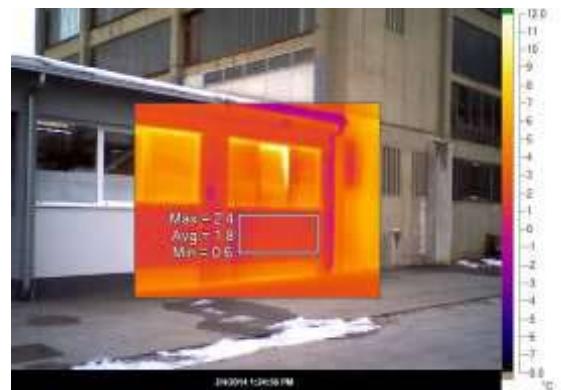
North facade

It can bee seen from the thermograms the quality of works and advantages of insulation which ensure the better energy efficiency of building.

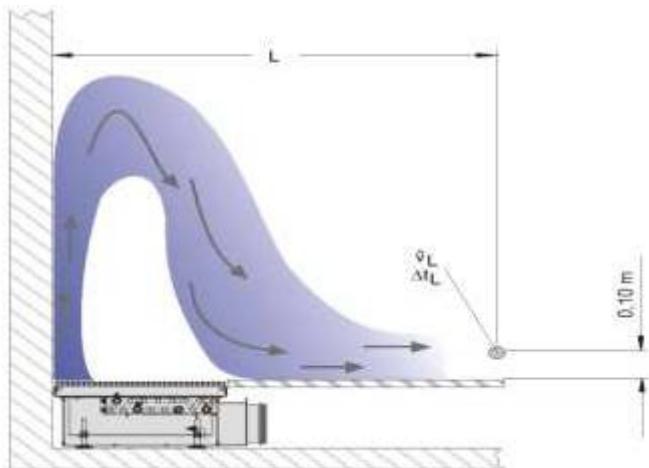
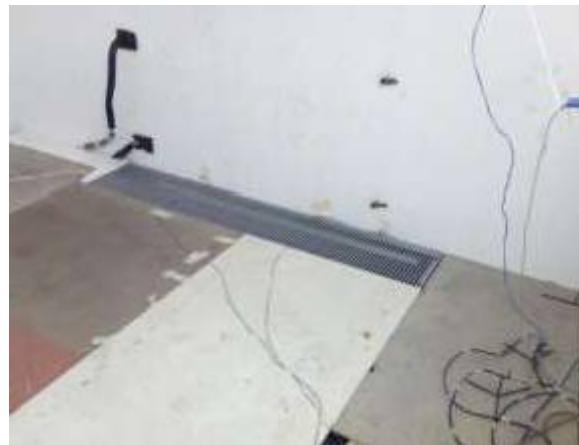
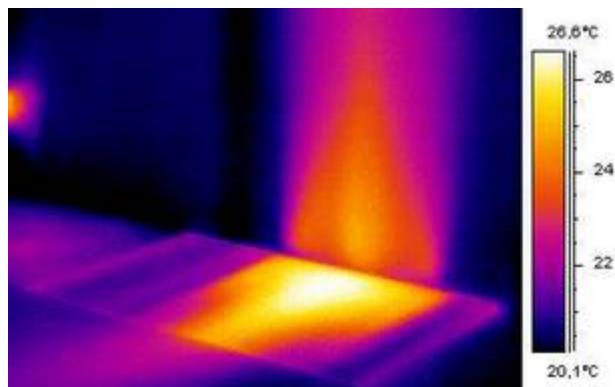
Heating mode  
Average chamber air temperature 21,3°C  
Water temperatures 40/35°C  
Temperature of inlet air 22°C  
Water flow 50 kg/h  
Air flow 35 m<sup>3</sup>/h  
Heating capacity 268 W

- unequal flow through convector
- unsatisfactory air profile in heating mode
- unsatisfactory air profile in cooling mode (acceptable at fan velocity number 3)

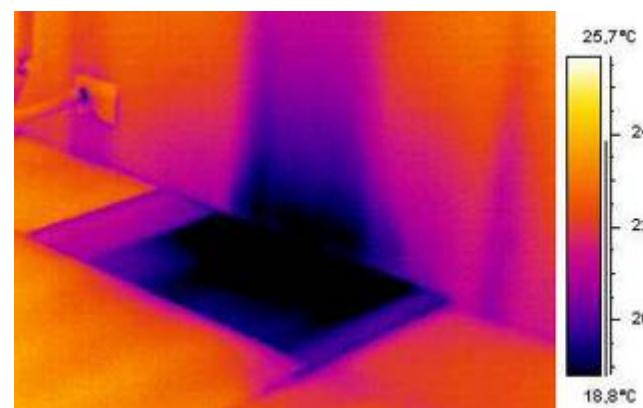
## Cooling mode

Average chamber air temperature 26,9 °C

Water temperatures 16,2/17,9°C

Inlet air temperature 18°C

Water flow 42,6 kg/h

Air flow 35 m<sup>3</sup>/h

Cooling capacity 210 W
